# Manhole Inspection Summary

Manhole # S27I\_\_002MH

Insp Date: **1/16/09 1:03 PM**

**Location** Address: **S.Amity St.**

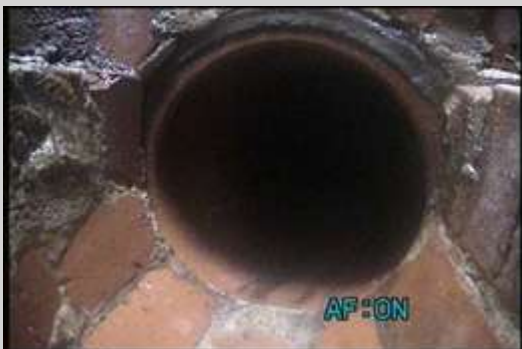
9 O'Clock Inflow

8 in. Circular Gravity Sewer  
Pipe In @ 9 O'Clock

Pipe Height: **8.4** (in.) Rod and Bar (Angled)  
Pipe Material: **Clay** ☐ Pipe Lined  
Invert Depth: **8.28** (ft.) Flow Characteristics: **Slow**  
Deposits: ☒ None ☐ Mud ☐ Sludge ☐ Debris ☐ Grease  
Silt Depth: **0** (in.) Deposits Extent:  
Infiltration: **None** Pipe Seal Cond: **Sound**
